Colorado Optical Gas Imaging Infrared Camera Pilot Project: Final Assessment

July 11, 2016

Author: Tim Taylor

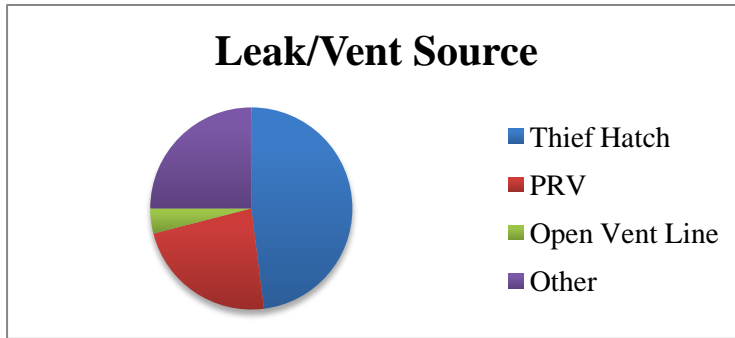
Of the total number of leaks and venting identified three-quarters were from the thief hatch, PRV or open vent line on controlled hydrocarbon liquid storage tanks. Overall, nearly half of all leaks and venting found during the project were from the thief hatch and nearly a quarter were from the PRV, indicating storage tanks as a primary source of emissions at well production facilities.

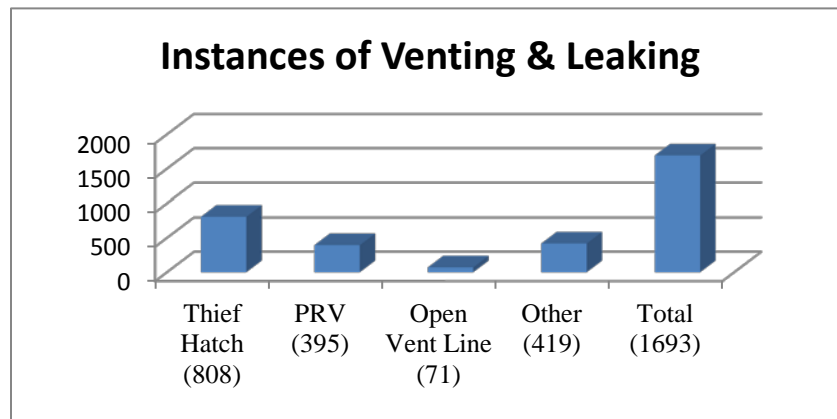
The chart below shows the number of instances of venting found from the thief hatch, PRV and open vent line on tanks, as well as “other” leaks (for example, from separator, vapor line, knockout tank, wellhead, etc.), and total number of instances of venting and leaking:
