DAIRY DIGESTERS

February 26, 2020

NORTHWEST CLEAN AIR AGENCY

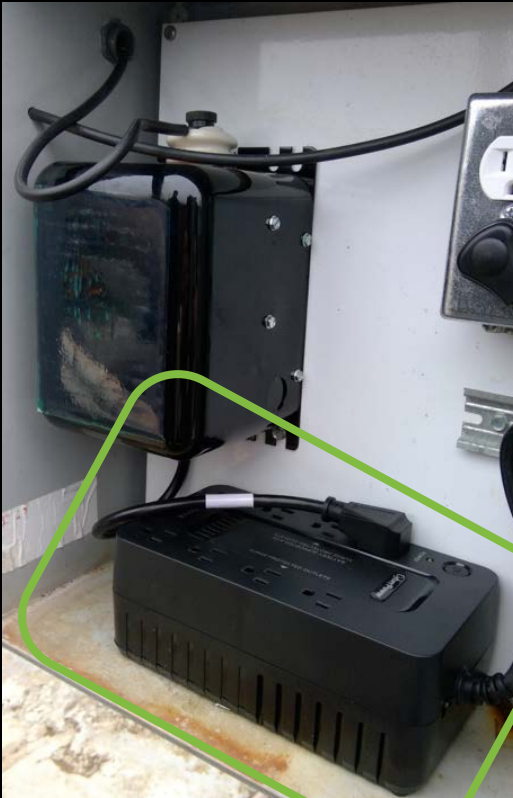
3.A. FLARING ISSUES

No spark-ignition during power outages

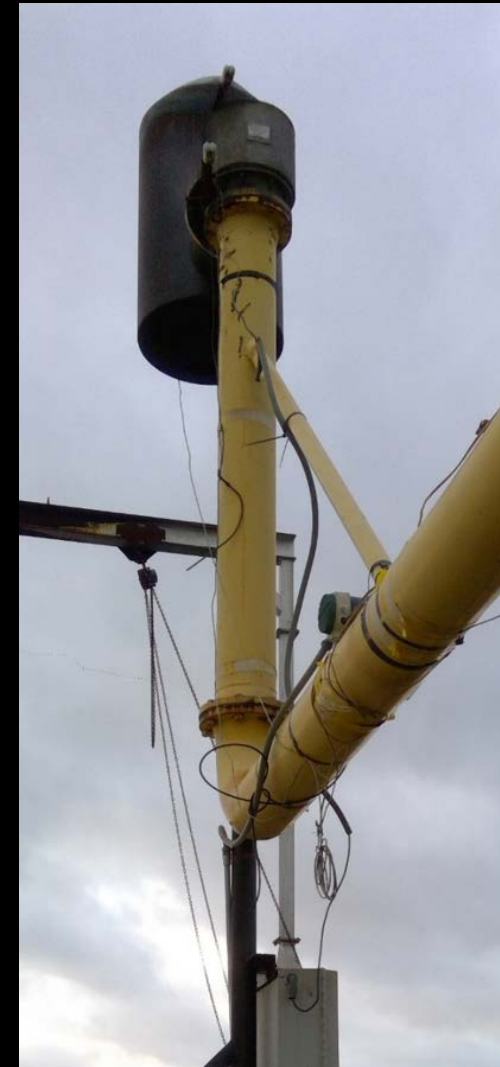
Flare ignition failures during normal operation – flow, but no flare

No Flare
Temp
18% of time

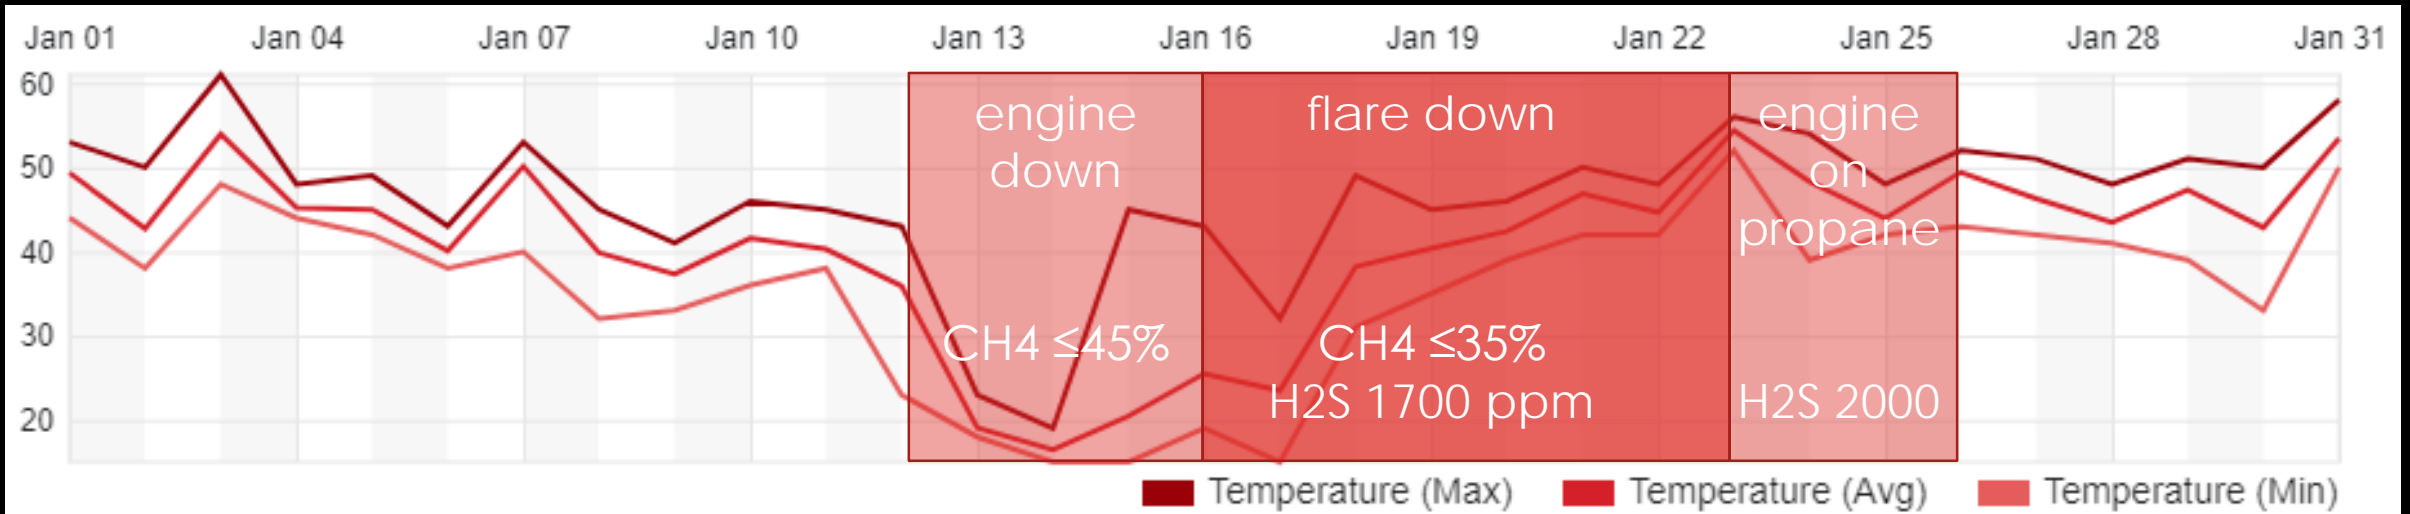
3.C. FLARING ISSUES

Flare ignition failure due to poor gas quality (e.g., an upset caused by freezing weather)

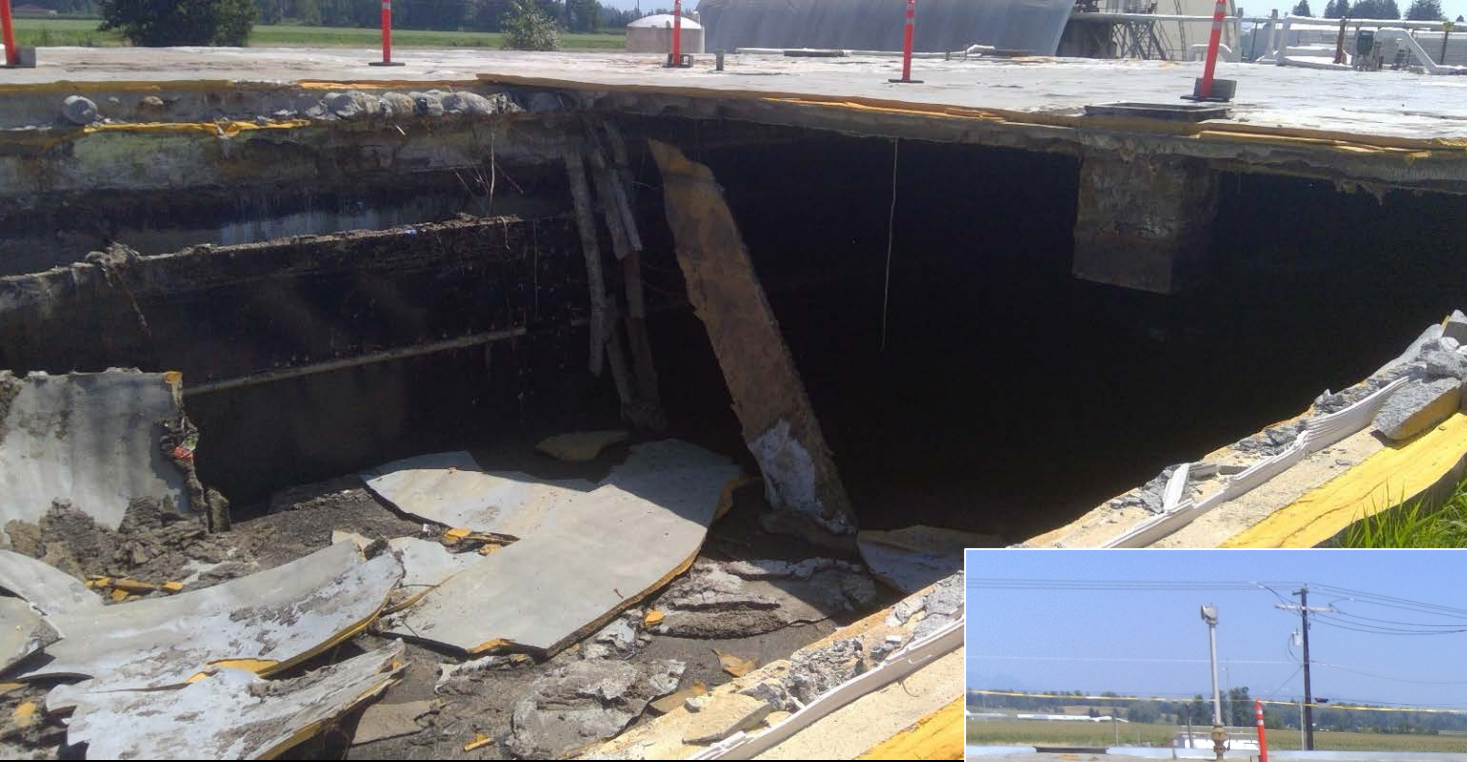
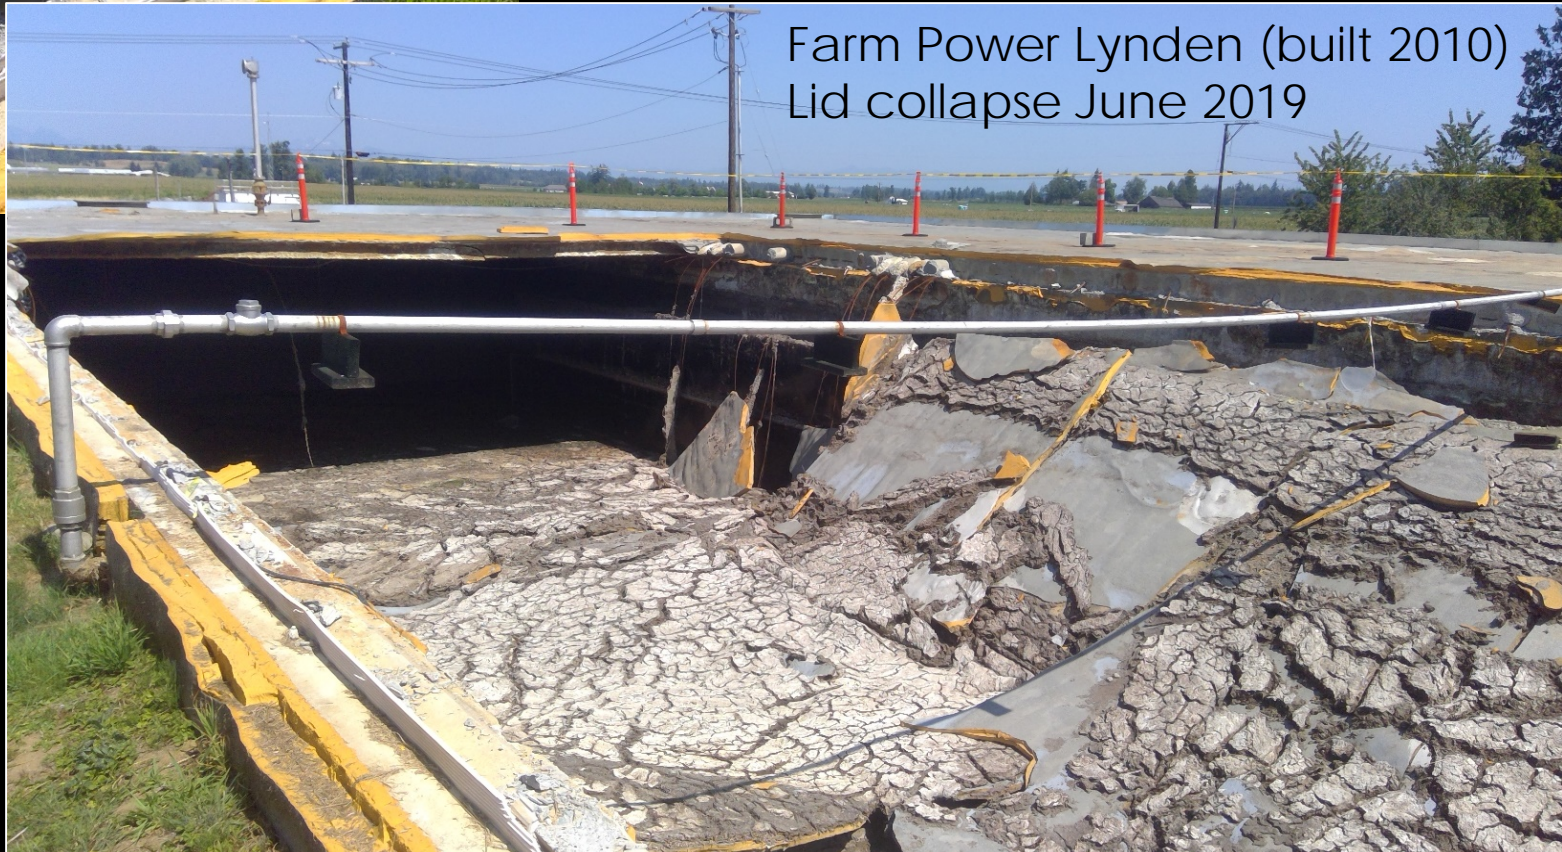
4. DIGESTER ROOF FAILURES

Farm Power Lynden (built 2010)
Lid collapse June 2019

- Result in alternate operations (i.e. run commercial natural gas)

Edaleen Cow Power (built 2012)
Lid collapse October 2019

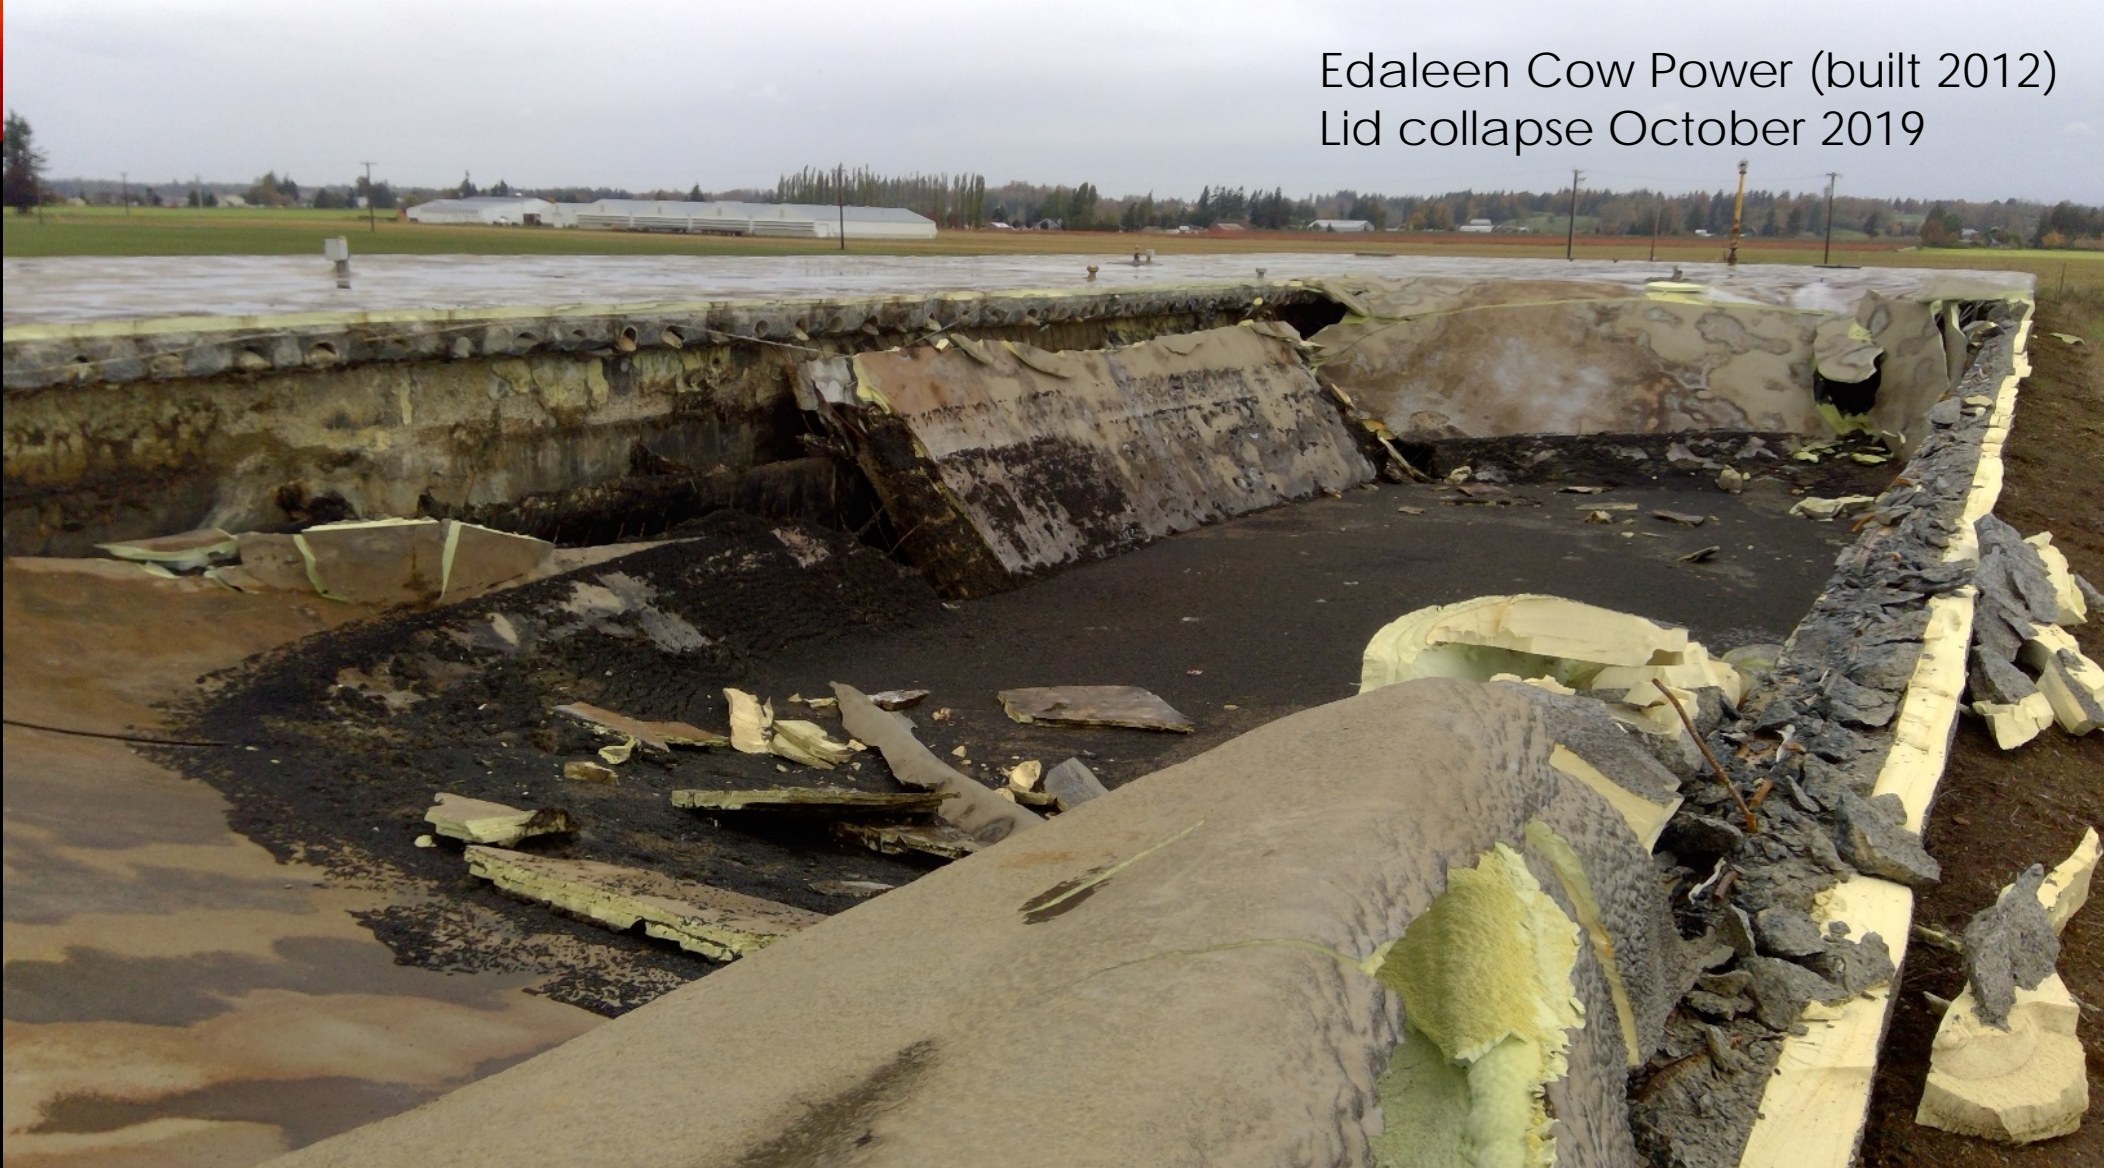
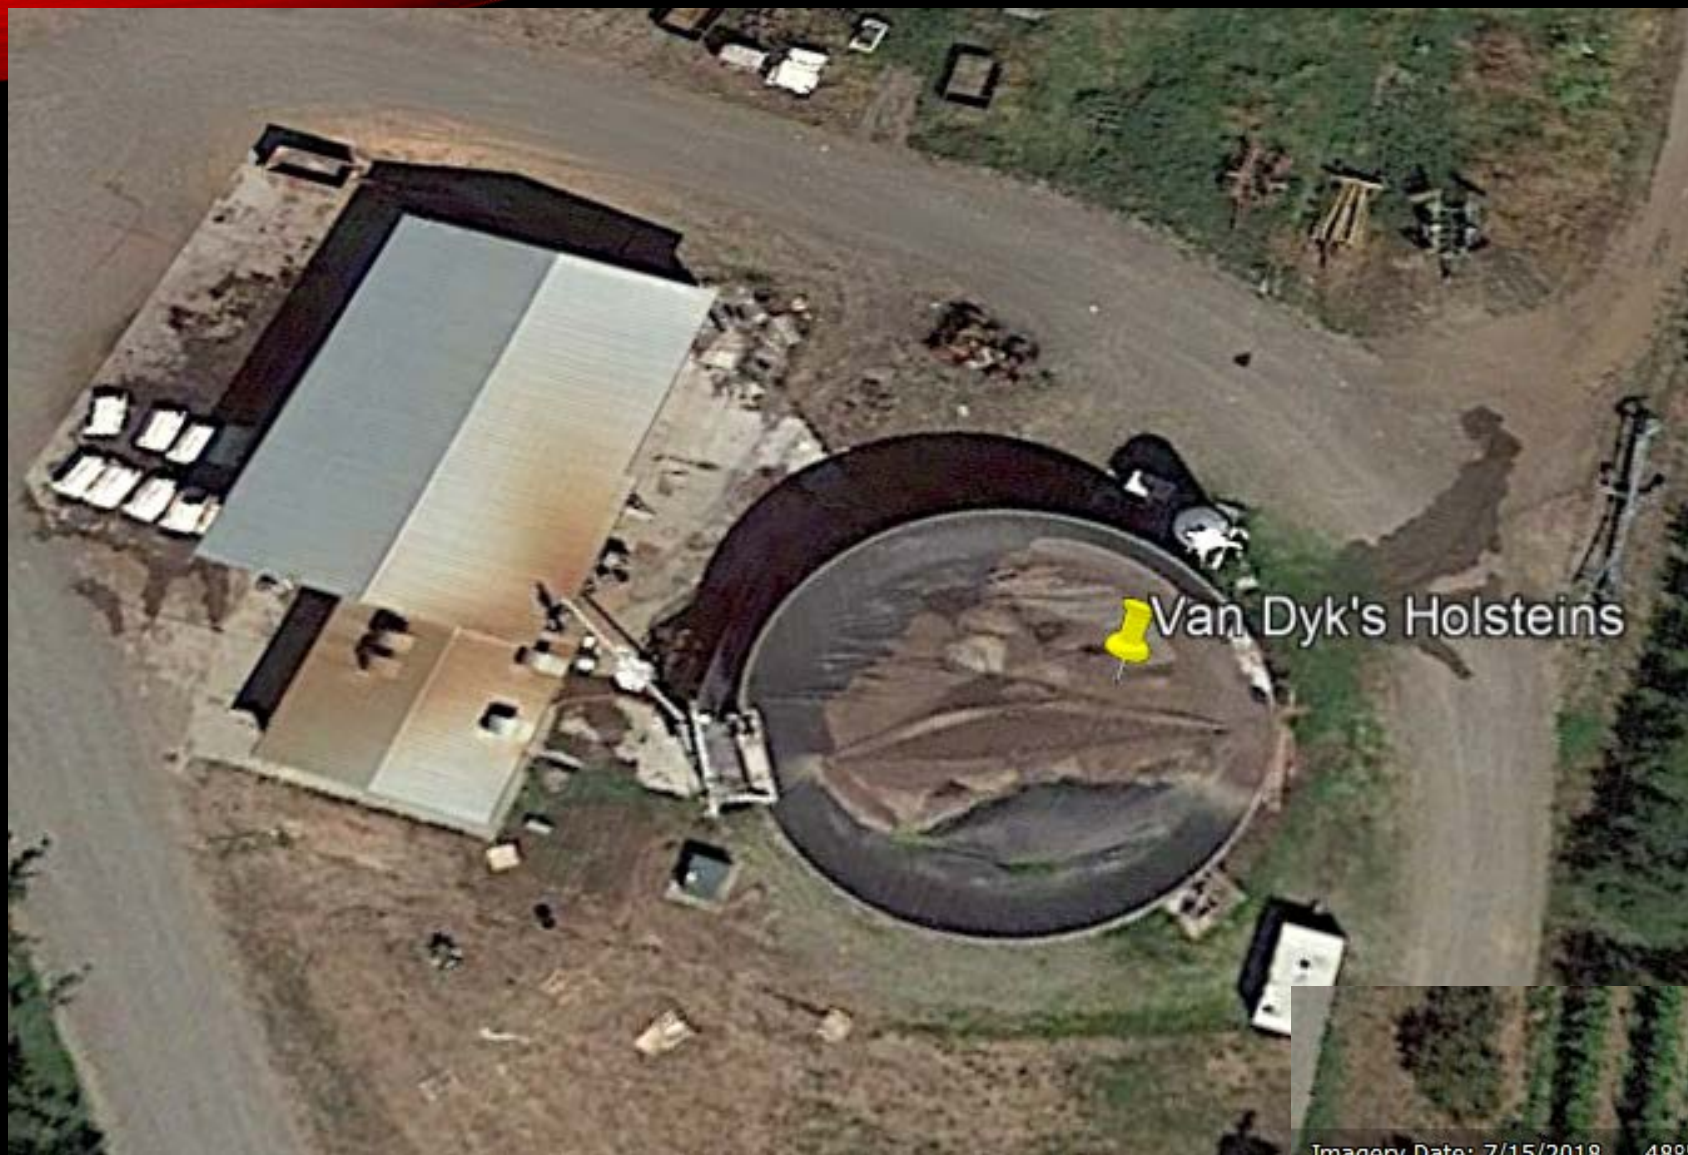
Van Dyk-s Holsteins (built 2011)
Lid split July 2018

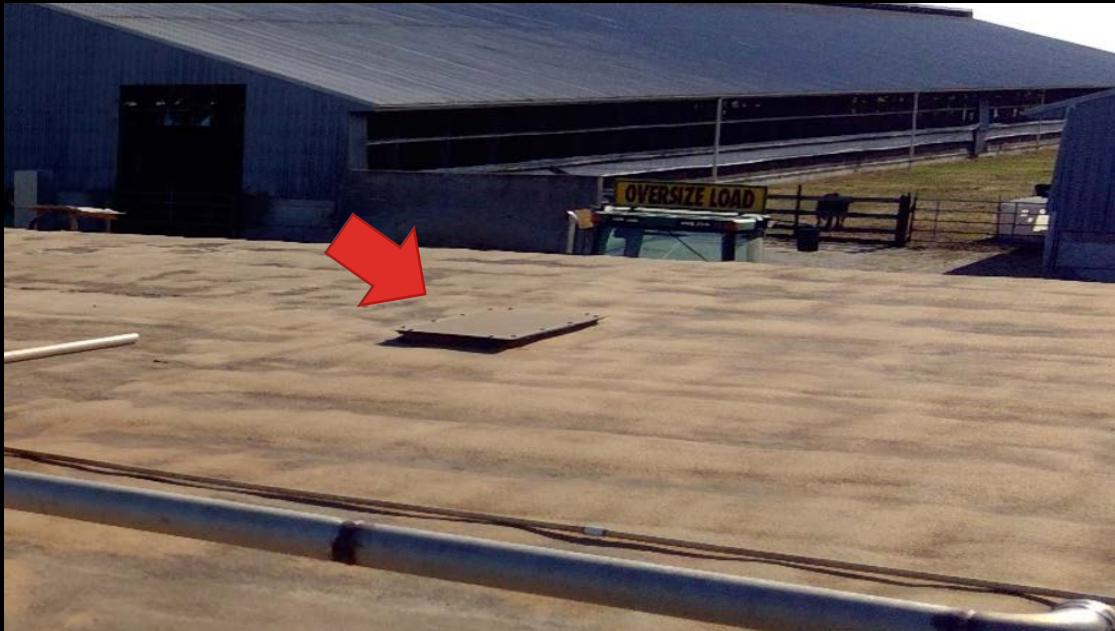
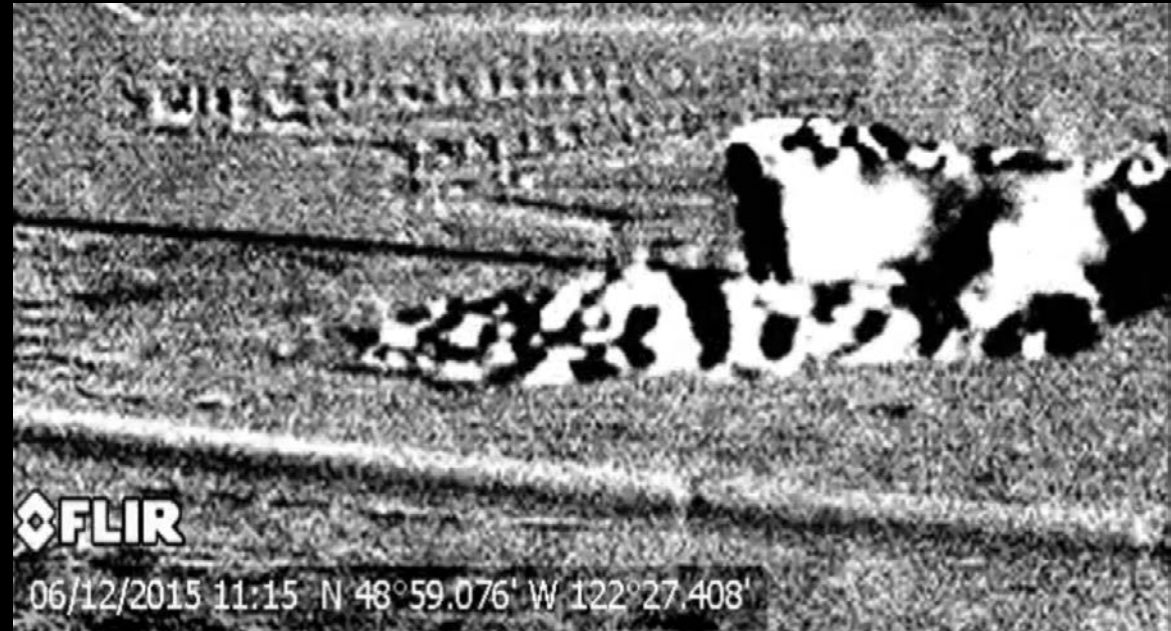
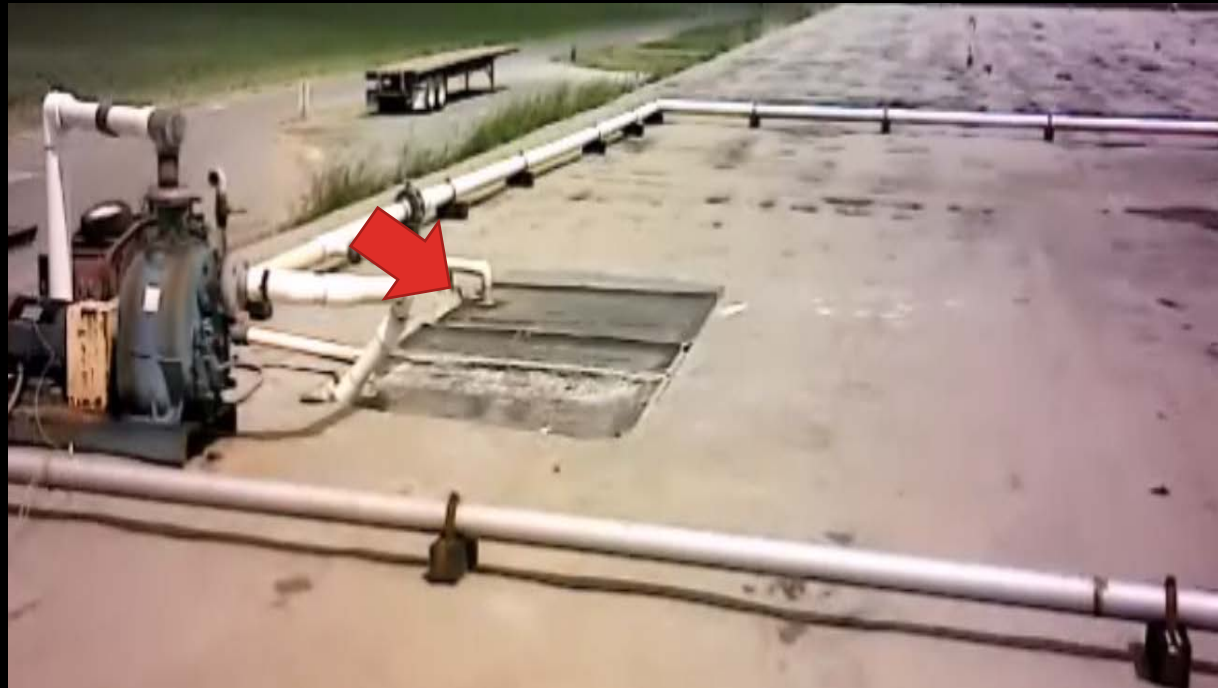
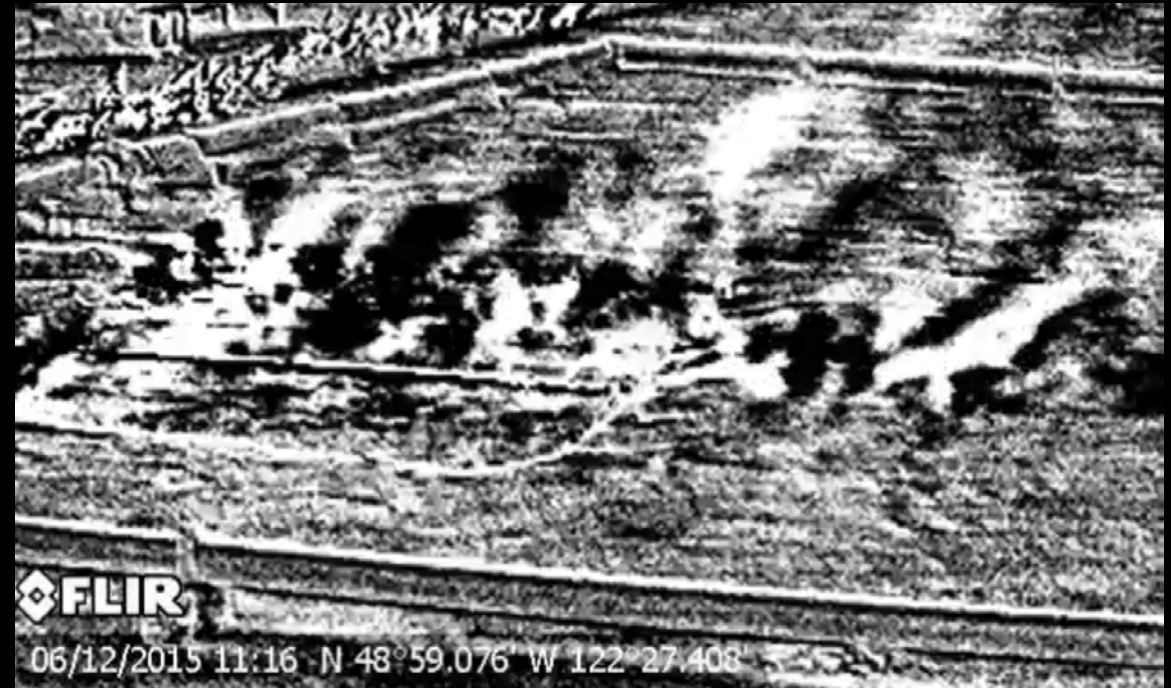
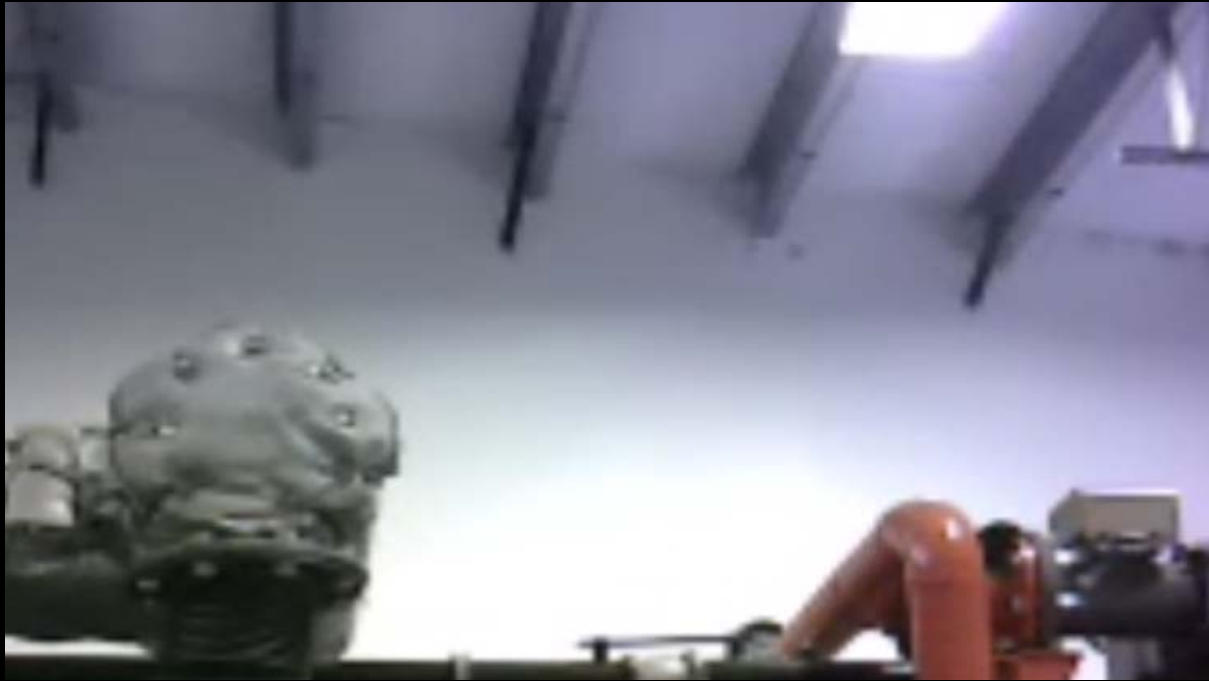
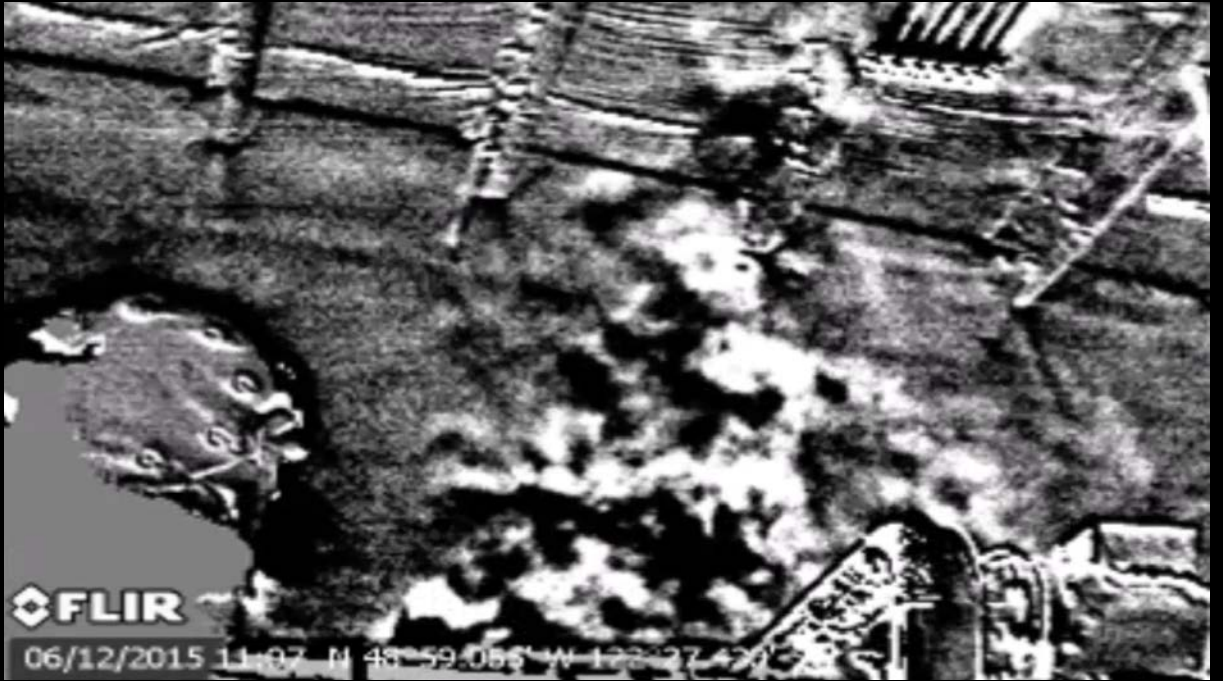
5. EQUIPMENT LEAKS

- Leaking equipment
