DAIRY DIGESTERS

February 26, 2020

NORTHWEST CLEAN AIR AGENCY

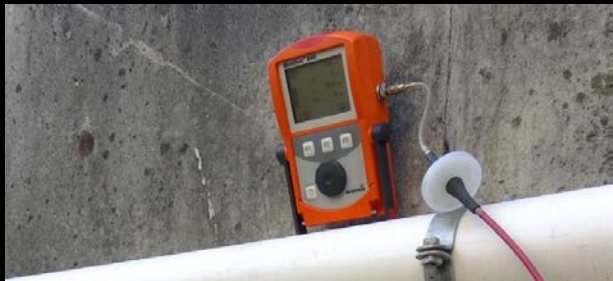
1. H2S CONCENTRATIONS

Anytime H2S Limit 550 ppm
30-day rolling limit 350 ppm

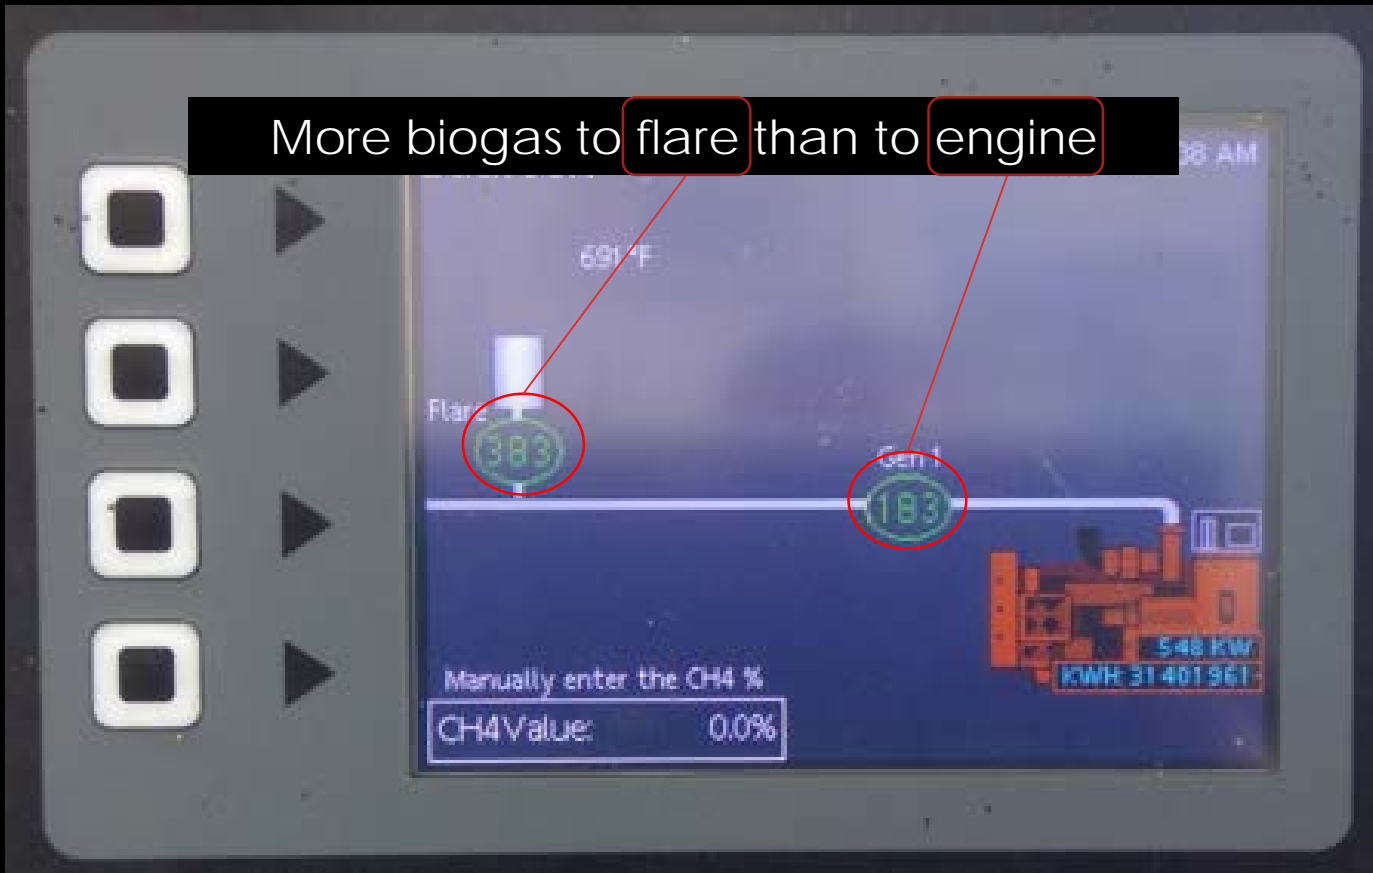
3.B. FLARING ISSUES

Permit applications indicated flaring $\leq 10\%$

33%	Total Gas Volume of Flare	108262019 CF
	Total Gas Volume of Engine	224813753 CF
	Total Gas Volume of Engine and Flare	333075772 CF
